Sugar Cove Berm Post Maintenance Effort #4 Monitoring

Sugar Cove, Spreckelsville, Maui, Hawaii

July 2023

Sea Engineering, Inc.
Makai Research Pier
Waimanalo, HI 96795

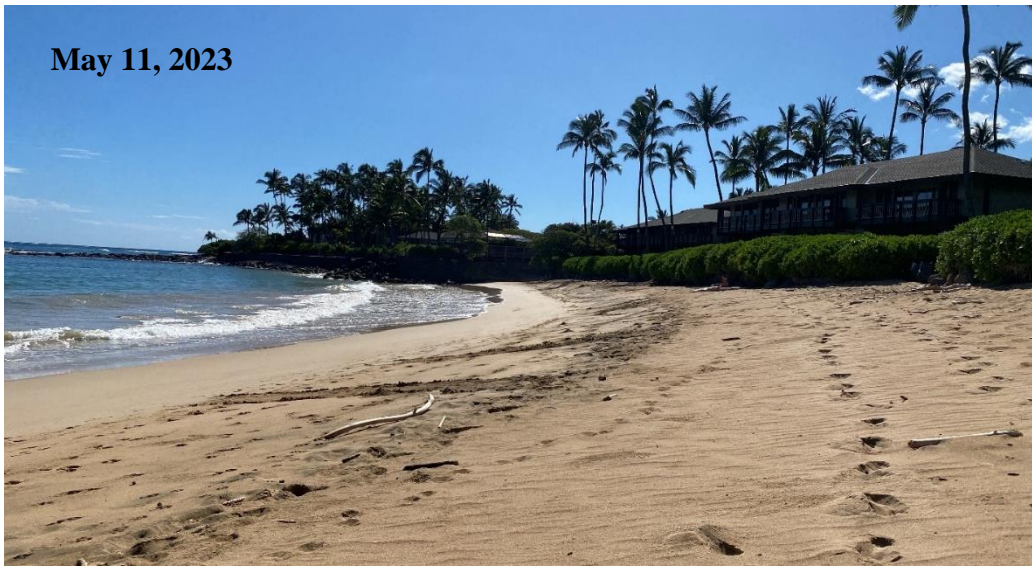
Figure 1-8. Looking east along the beach, from near the middle of the maintenance area

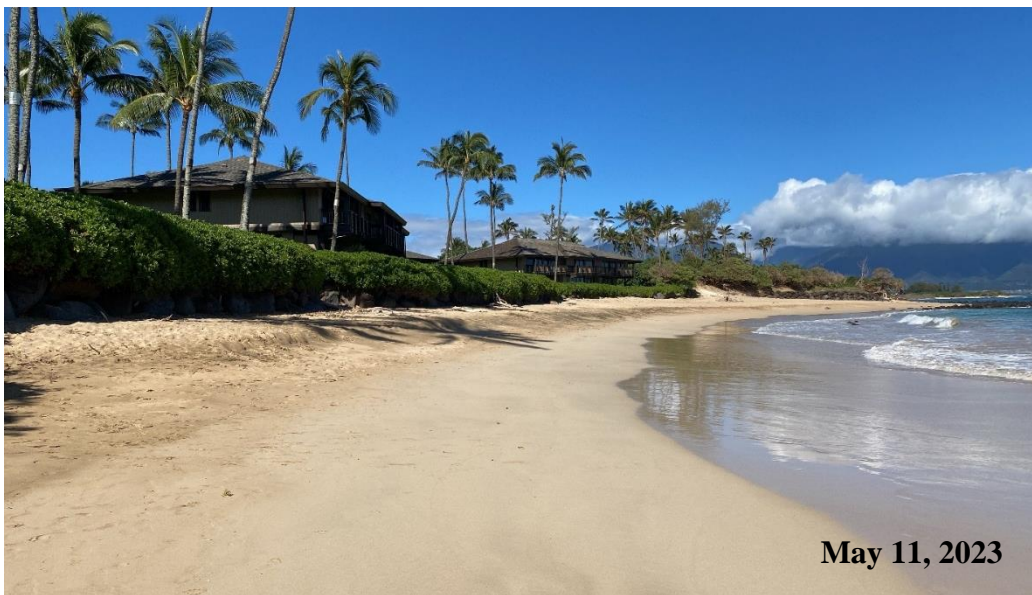
Figure 1-9. Looking west along the beach, from near the eastern end of the maintenance area

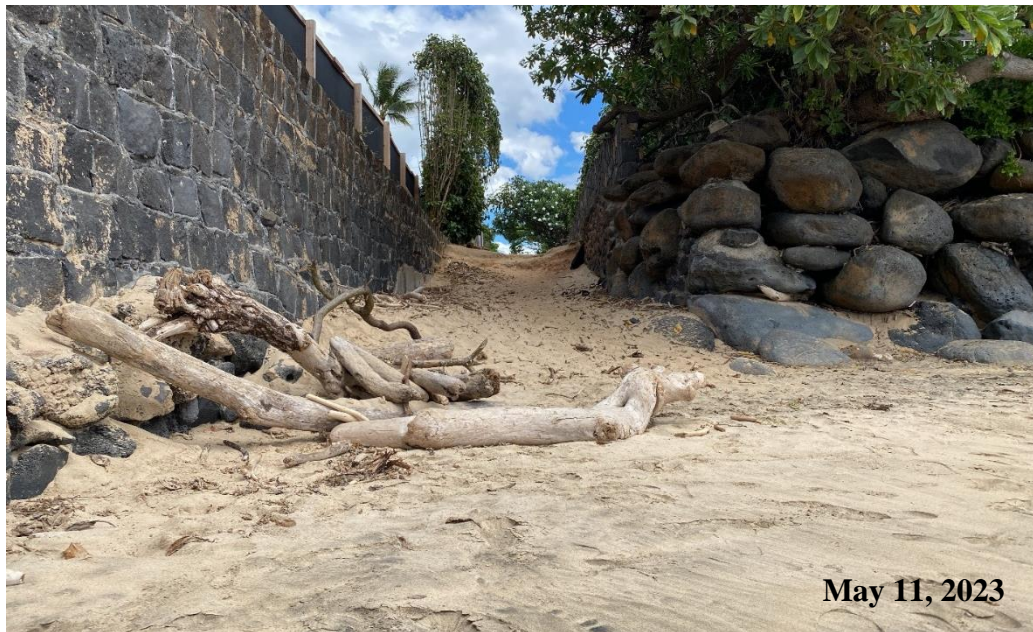
Figure 1-10. Looking inland through the county beach access at the eastern end of the maintenance area

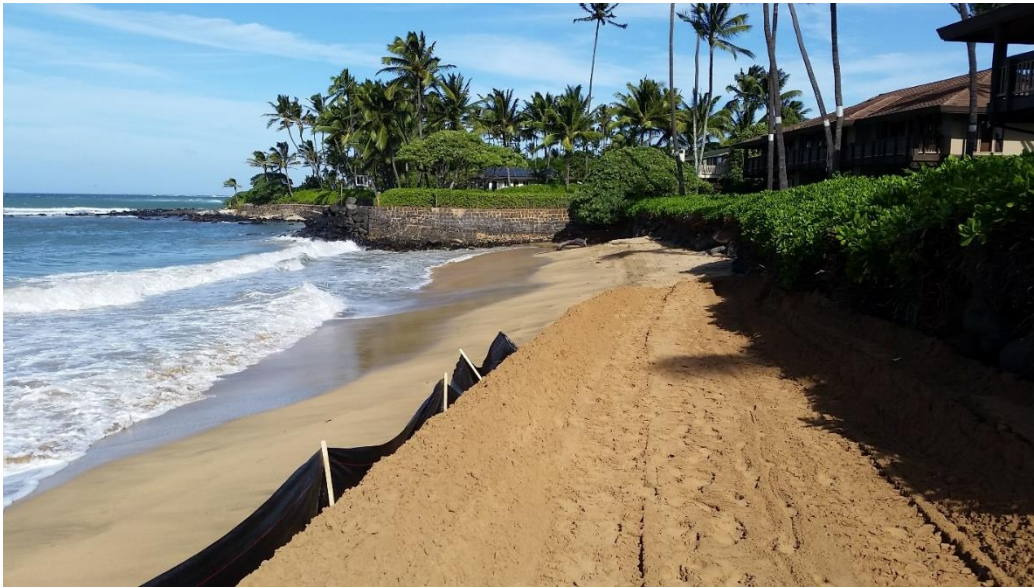
Figure 4-5. Graded sand with finished makai slope and silt fencing ending near Transect 3 (Maintenance #1)

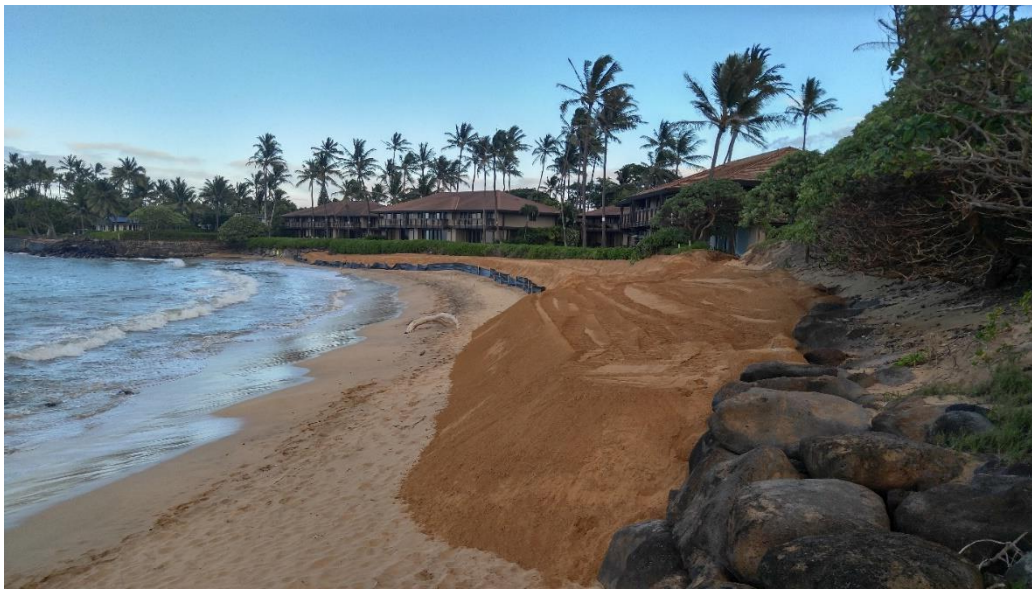
Figure 5-5. Beach and berm condition after placement on September 7, 2016 (Maintenance #2)

Final Grade: The upper portion of the berm maintenance sand was placed atop the low elevation berm (Figure 5-4) on the beach profile and was graded to a nearly horizontal plane (Figure 5-5). The makai face of the material was graded to as gentle a slope as was possible, given the already deflated and narrow beach profile.

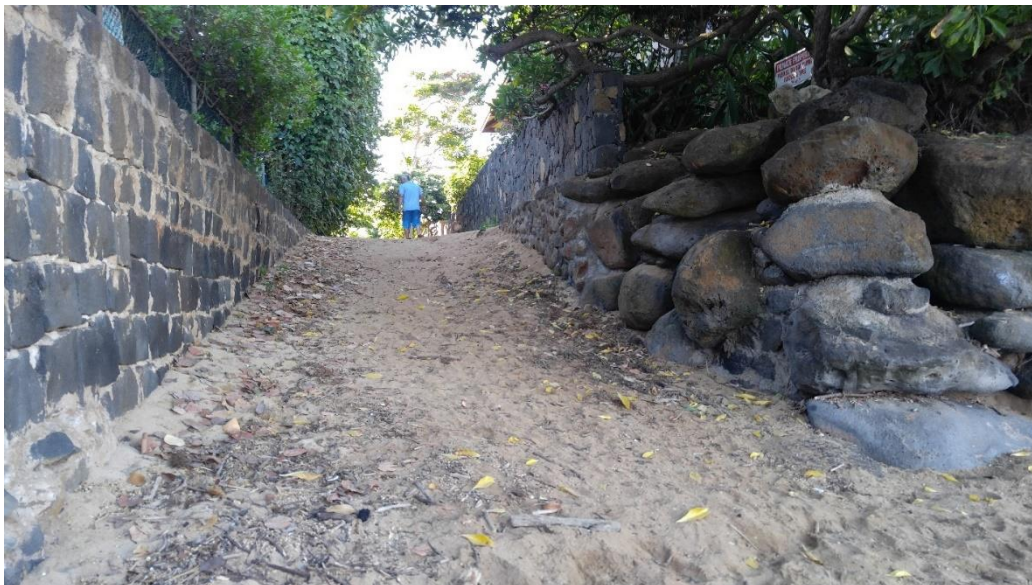
Figure 5-6. County of Maui beach access path during sand placement (Maintenance #2)

Placement: A single operator, contracted by Tavares Trucking, used a Caterpillar D4G bulldozer (Figure 5-2) to move sand along the berm and shape the new sand bank. Sand pushing and grading were completed from west to east along the berm. All sand moving and grading was conducted on the berm, makai of the shoreline vegetation and well inland from mean higher high water. The maintenance sand berm abutted the boulders and sand bank on the mauka side, and extended from the west end of the property to Transect 3 where the erosion was too severe for the bulldozer to spread sand without entering the water (Figure 5-3). No sand was added to the access path because it was still full. Too much sand on the path would make it too steep of a slope.

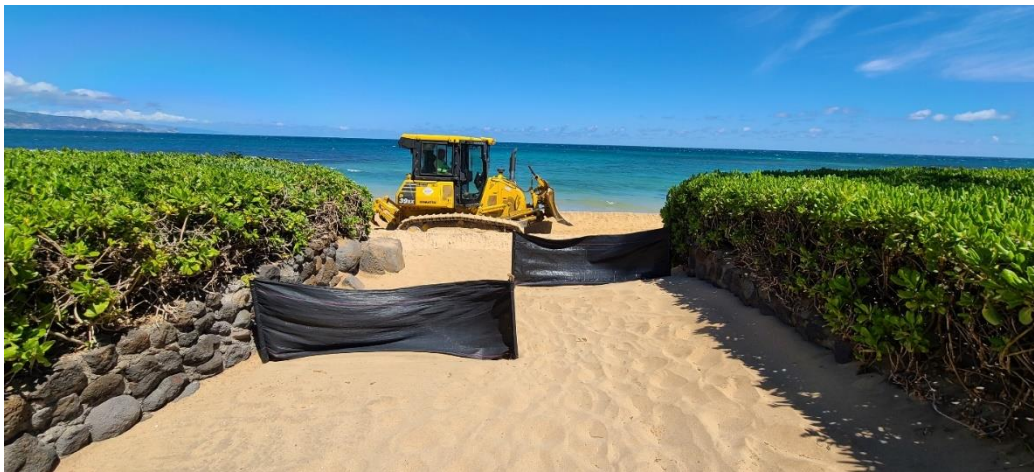
Figure 6-2. Bulldozer spreading sand along the berm (Maintenance #3)

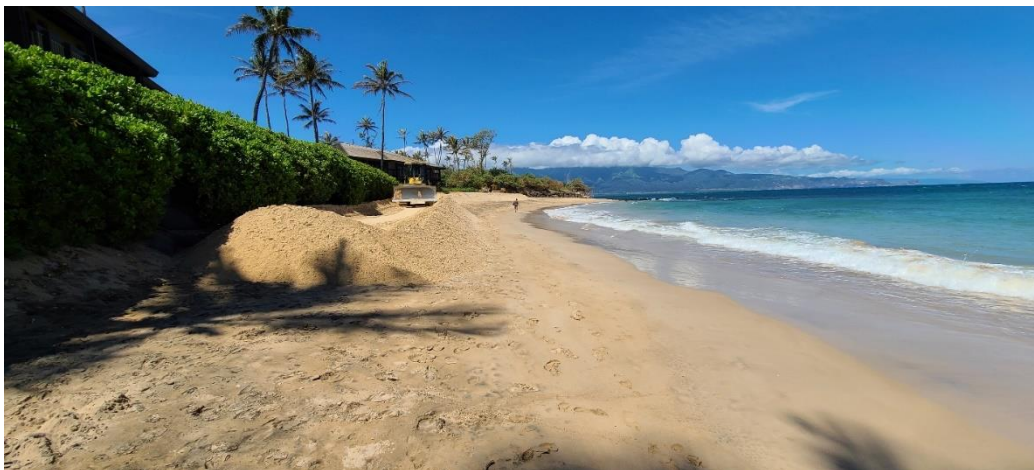
Figure 6-3. Graded sand with finished makai slope and silt fencing ending near Transect 3 (Maintenance #3)

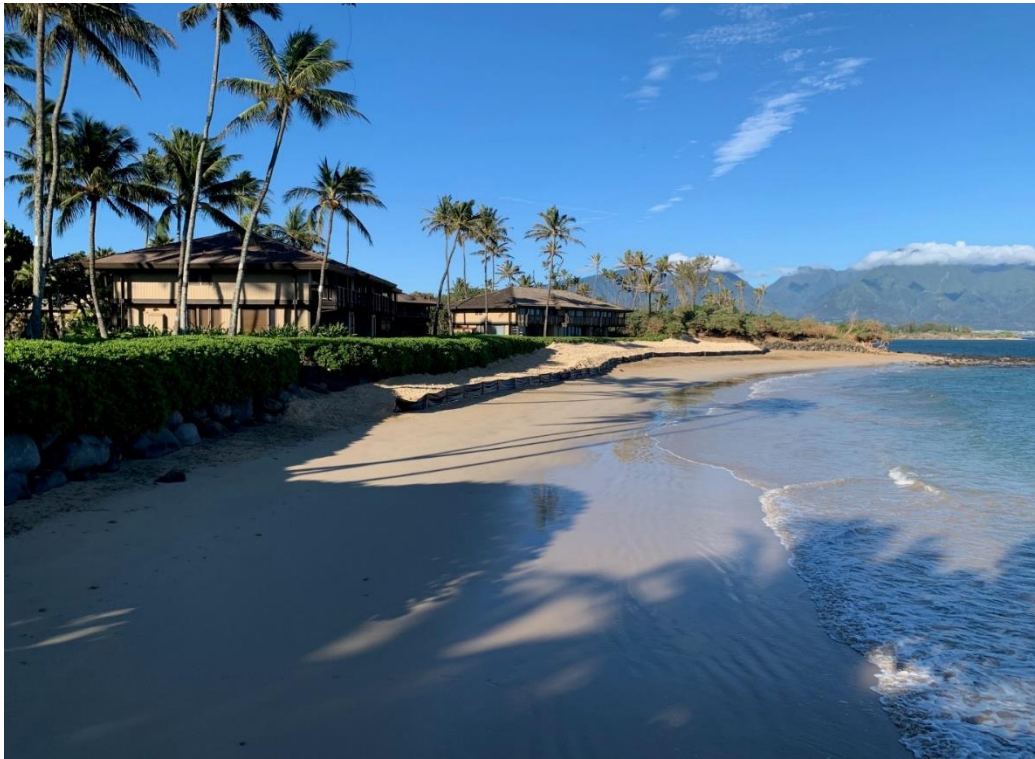
Figure 6-4. Beach and berm condition after placement on September 7, 2016 (Maintenance #2)

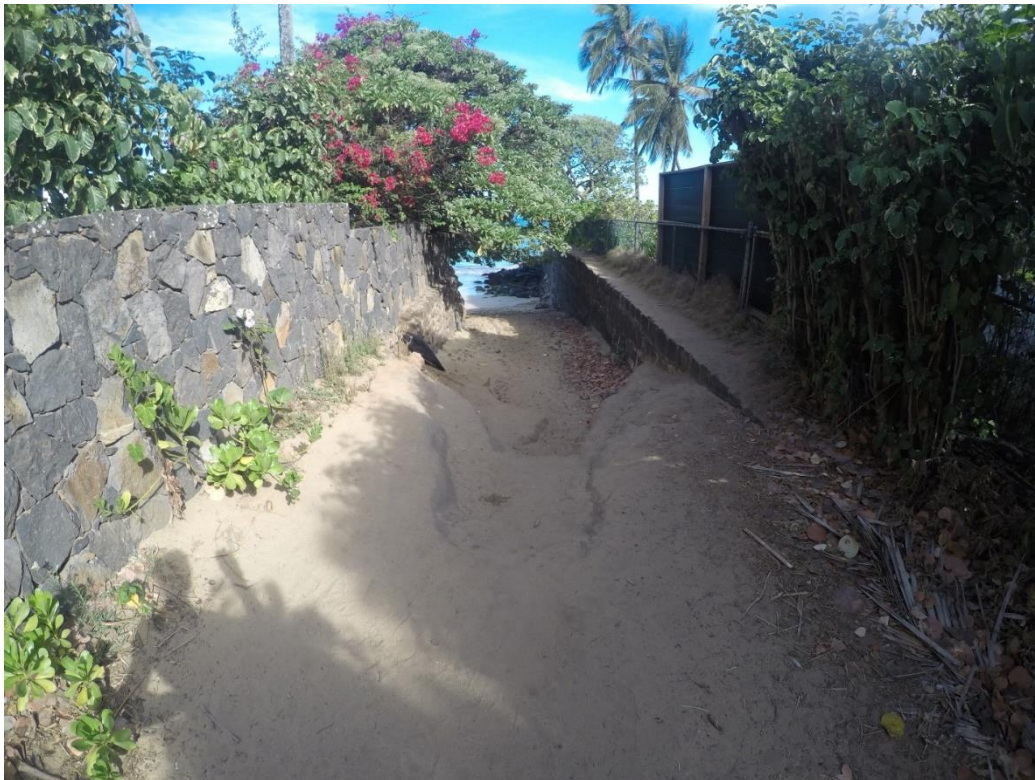
Figure 6-5. County of Maui beach access path during sand placement (Maintenance #2)

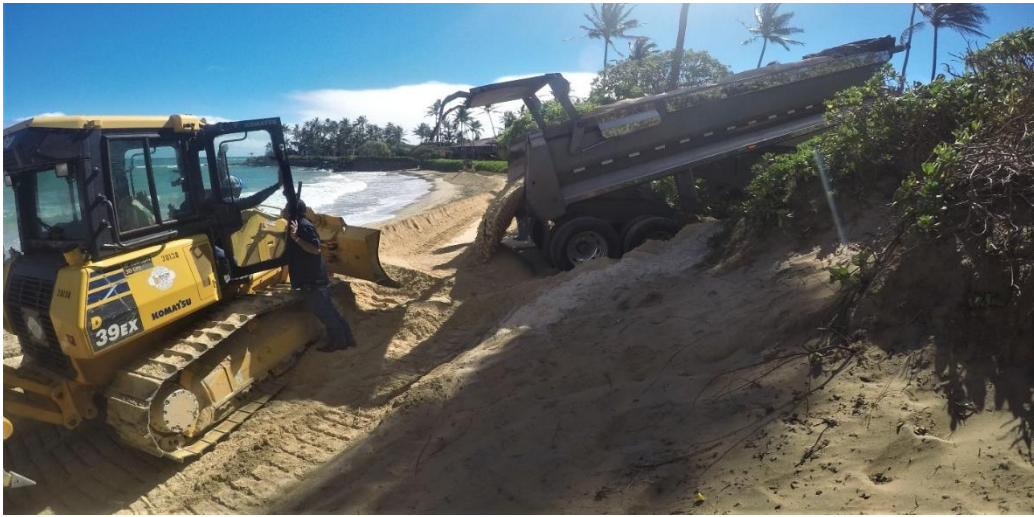
Delivery Method: The sand was first shipped from Oahu to Maui on a barge. Several delays with the barge and weather resulted in a 5-day delay of arrival to Maui. The Pacific Aggregate sand was located on the barge for the duration of the delay. The sand arrived on September 28, 2021. From Kahului Harbor, Gnomes Trucking and Tavares Trucking utilized vehicles to maintain a consistent delivery pace of about 12 trucks per hour for a total of about 60 truckloads between 1000 and 1700. Truck delivery of sand to the berm was at the west end of the embayment, through the Sugar Cove property to the public beach. A small gap was cut into the sand bank (Figure 7-1) allowing the trucks to deliver sand directly to the berm.

Figure 7-1. Dump truck delivering sand to the west end of the cove for placement on the berm (Maintenance #4)

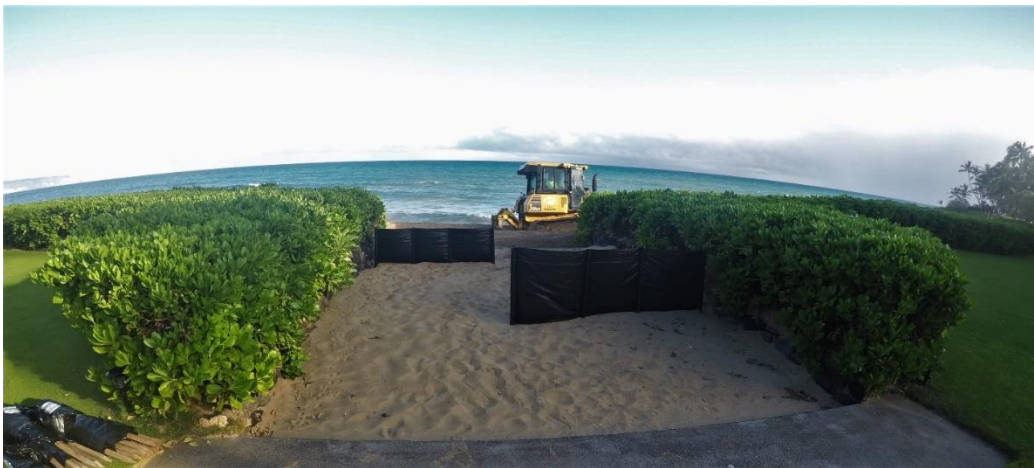
Placement: Two operators, contracted by Tavares Trucking, used two Komatsu 39EX bulldozers (Figure 7-2) to move sand along the berm and shape the new sand bank. Sand pushing and grading were completed from west to east along the berm. All sand moving and grading was conducted on the berm, makai of the shoreline vegetation and well inland from mean higher high water. The maintenance sand berm abutted the boulders and sand bank on the mauka side and extended from the west end of the property to the wall at the east end of the beach (Figure 7-3). No sand was added to the access path because it was still full. Too much sand on the path would make it too steep of a slope.

Figure 7-2. Bulldozer spreading sand along the berm (Maintenance #4)

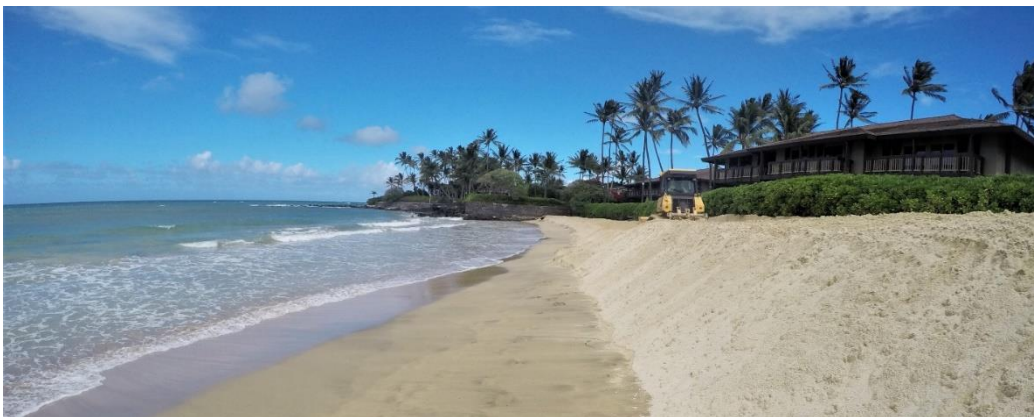
Final Grade: The upper portion of the berm maintenance sand was placed atop the low elevation berm (Figure 7-3) on the beach profile and was graded to a nearly horizontal plane (Figure 7-4). The makai face of the material was graded to as gentle a slope as was possible, given the already deflated and narrow beach profile.

Figure 7-3. Graded sand with finished makai slope ending near the public access at the eastern neighbor's seawall (Maintenance #4)

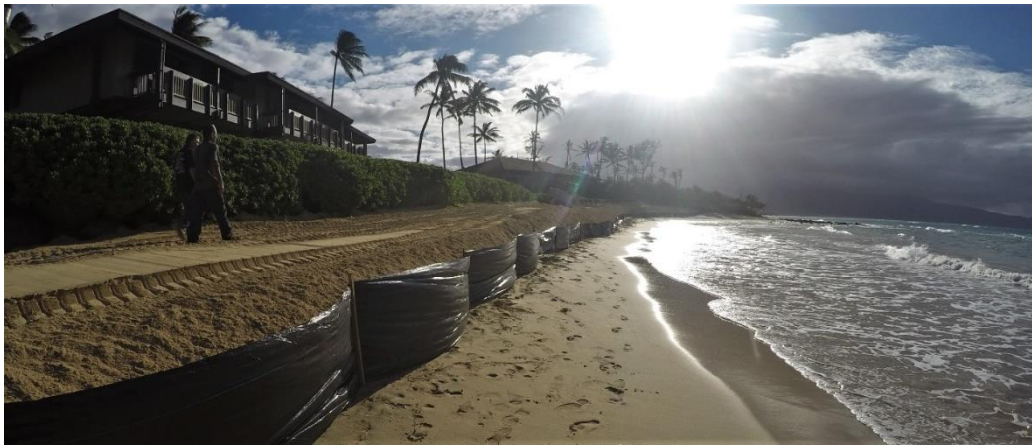
Figure 7-4. Beach and berm condition after placement on September 29, 2021 (Maintenance #4)

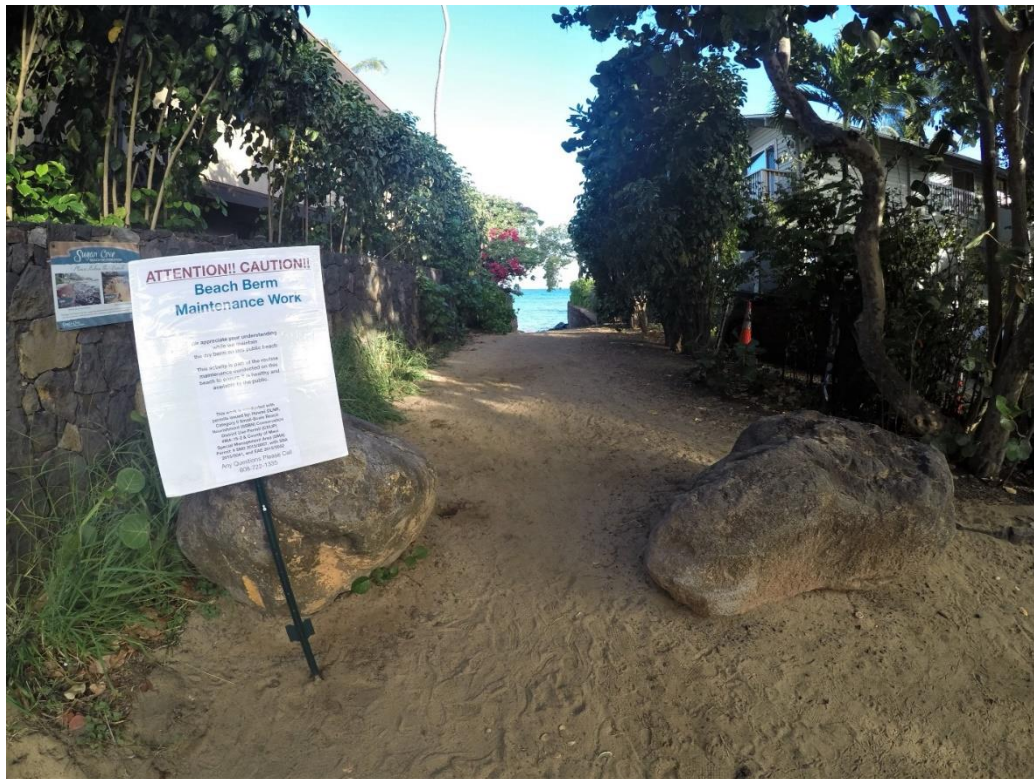
Figure 7-5. County of Maui beach access path during sand placement (Maintenance #4)

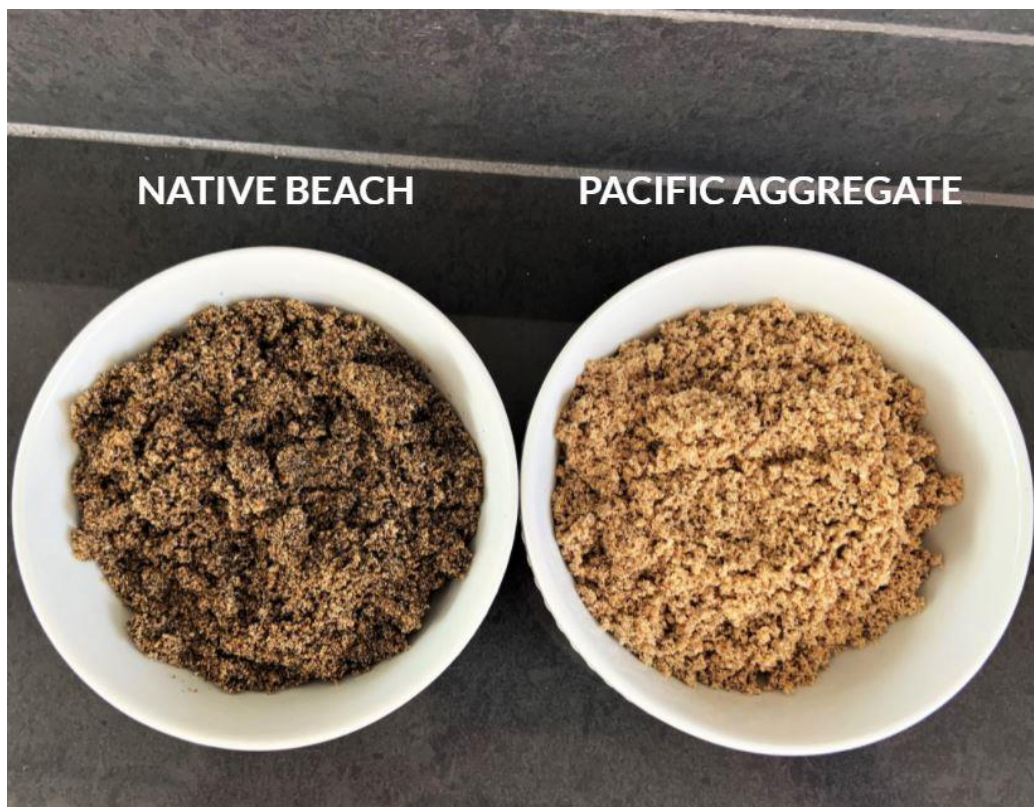
The pre-maintenance beach sand is a combination of native and fill material that have intermixed along the coastline. These 2021 samples were collected on September 28, 2021. Examples of the beach composite sand and the aggregate for maintenance #4 are shown in Figure 8-10.

Figure 8-10. Samples of sand from the native beach at Sugar Cove compared to the aggregate used for berm maintenance #4

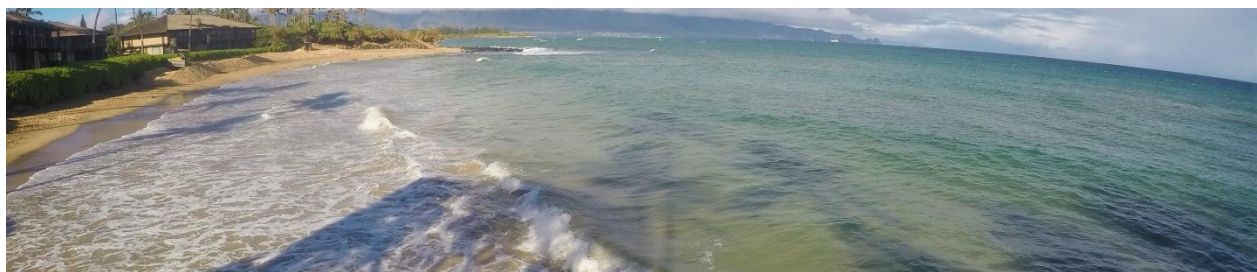
Figure 8-25. Water quality conditions at Sugar Cove (morning, September 28, 2021)

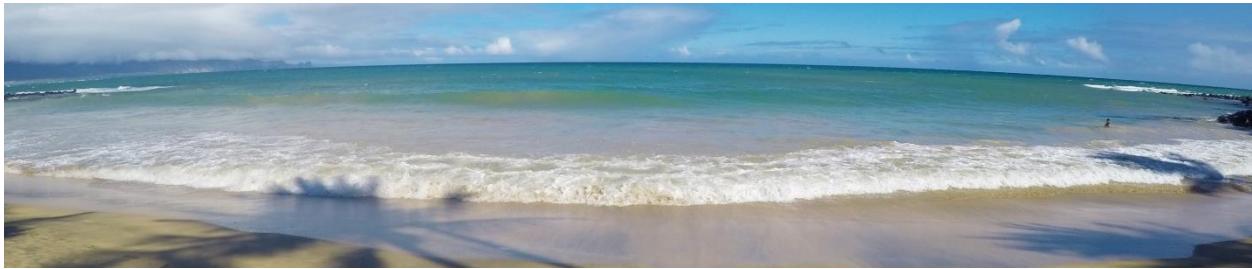
Figure 8-26. Water quality conditions at Sugar Cove (midday, September 28, 2021)

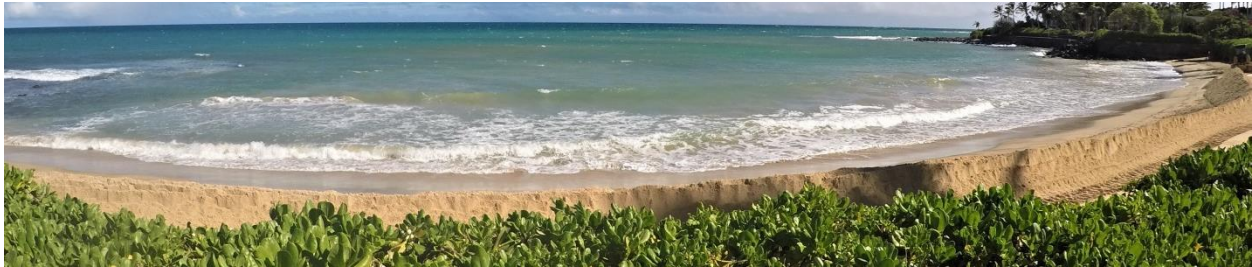
Figure 8-27. Water quality conditions at Sugar Cove (afternoon, September 28, 2021)

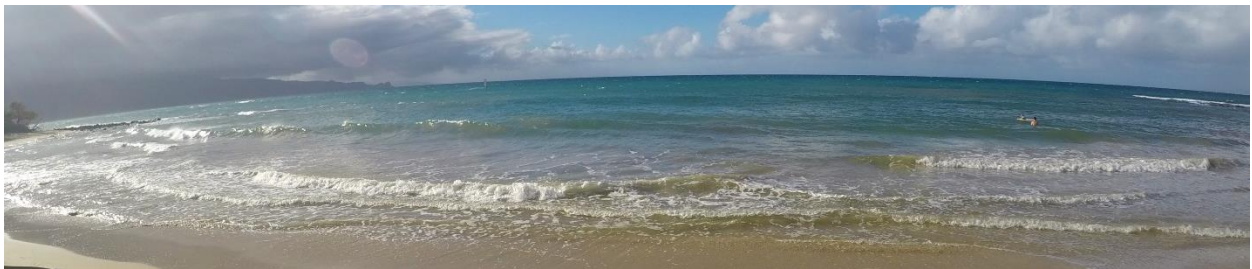
Figure 8-28. Water quality conditions at Sugar Cove (end of day, September 28, 2021)

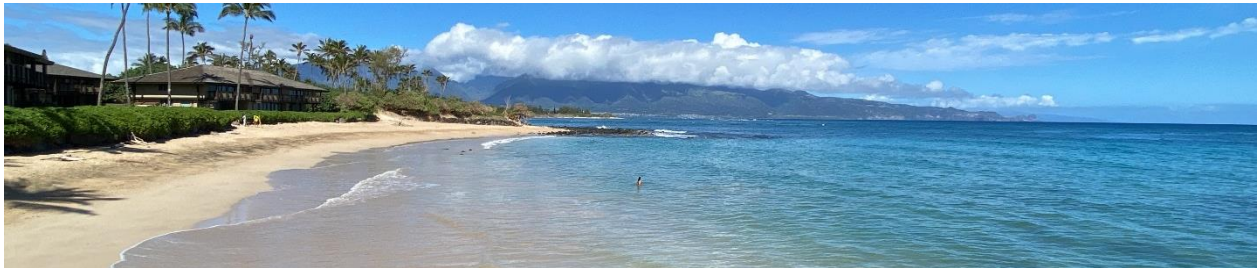
Visual observations for water quality were collected periodically throughout the day. Water quality in the nearshore, or between the shoreline and the reef crest offshore, was clear in the morning and began getting more turbid as wave activity increased (Figure 8-25 to Figure 8-28, Table 8-11). Observations of the nearshore waters at Sugar Cove, Baldwin Beach, and Laulea (the western cove abutting Sugar Cove) are presented in Table 8-11.

Figure 8-29. Water quality conditions at Sugar Cove (morning, May 11, 2023)

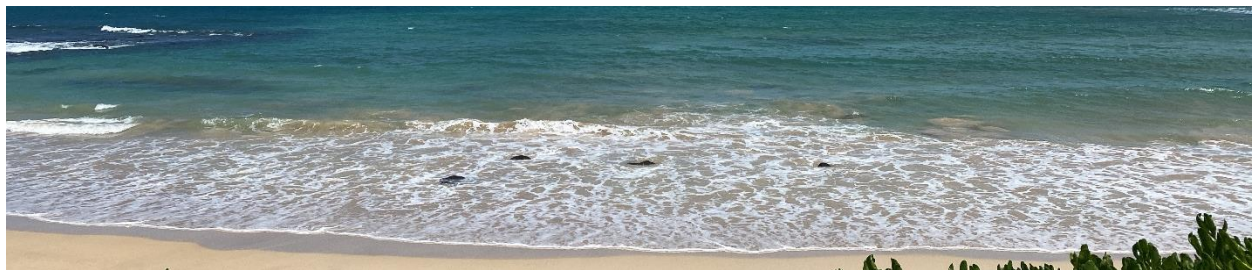
Figure 8-30. Water quality conditions at Sugar Cove (midday, May 11, 2023)

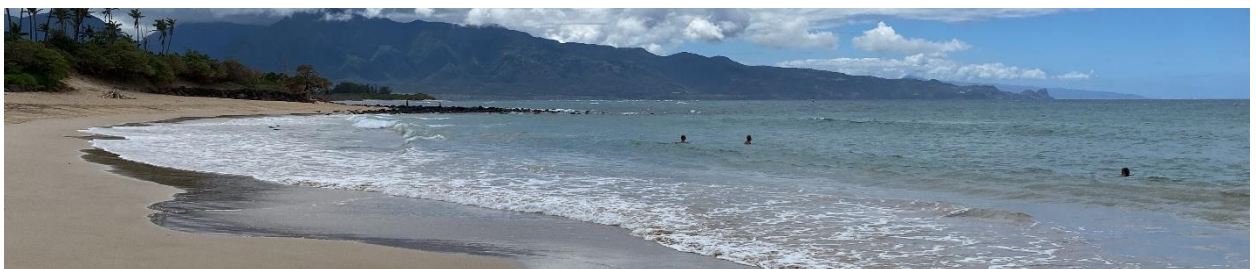
Figure 8-32. Water quality conditions at Sugar Cove (end of day, May 11, 2023)

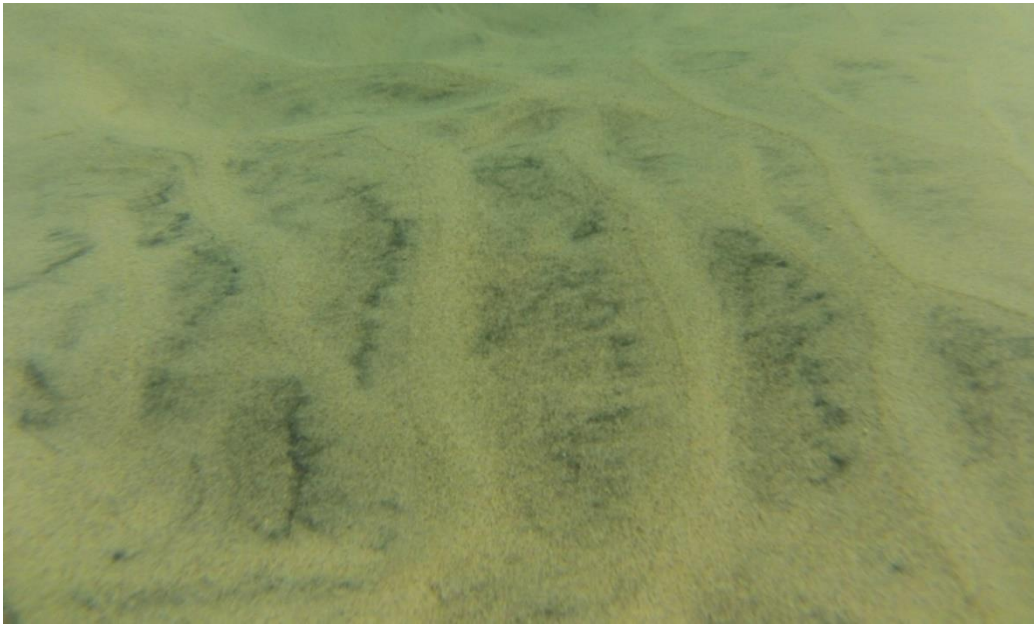
Figure 8-34. Sand substrate representative of the nearshore sand field

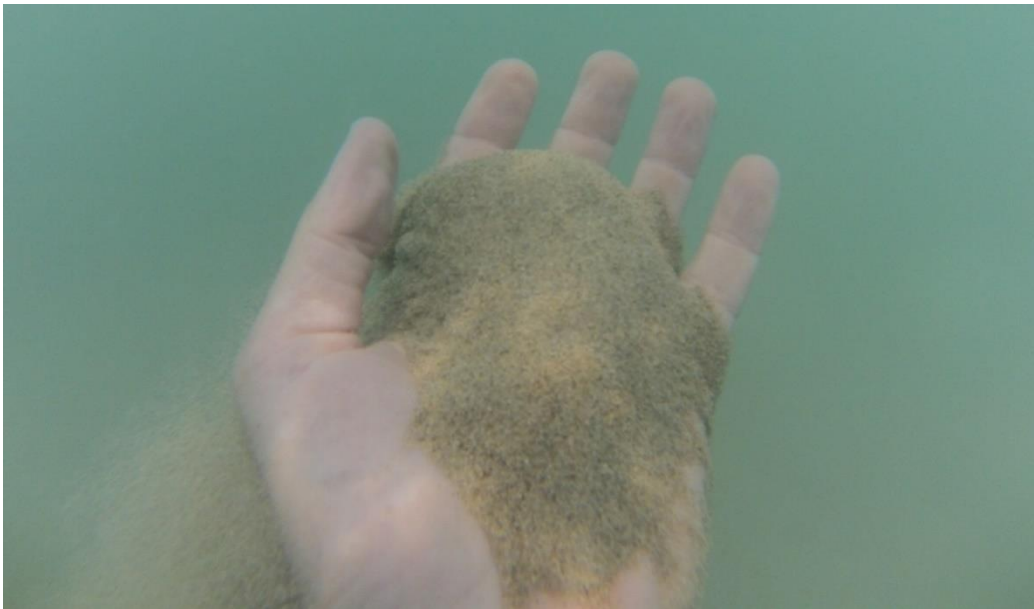
Figure 8-35. Nearshore sand from the sand bar similar to the restored beach sand

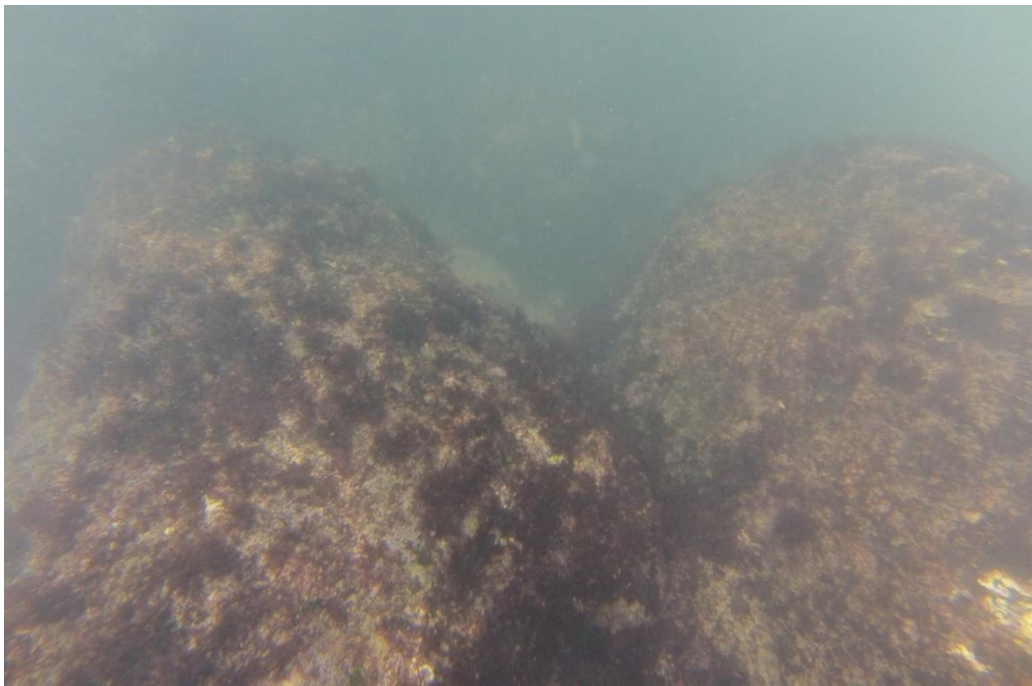
Figure 8-38. Turf algae, hard bottom, and boulders representative of the western side of the cove

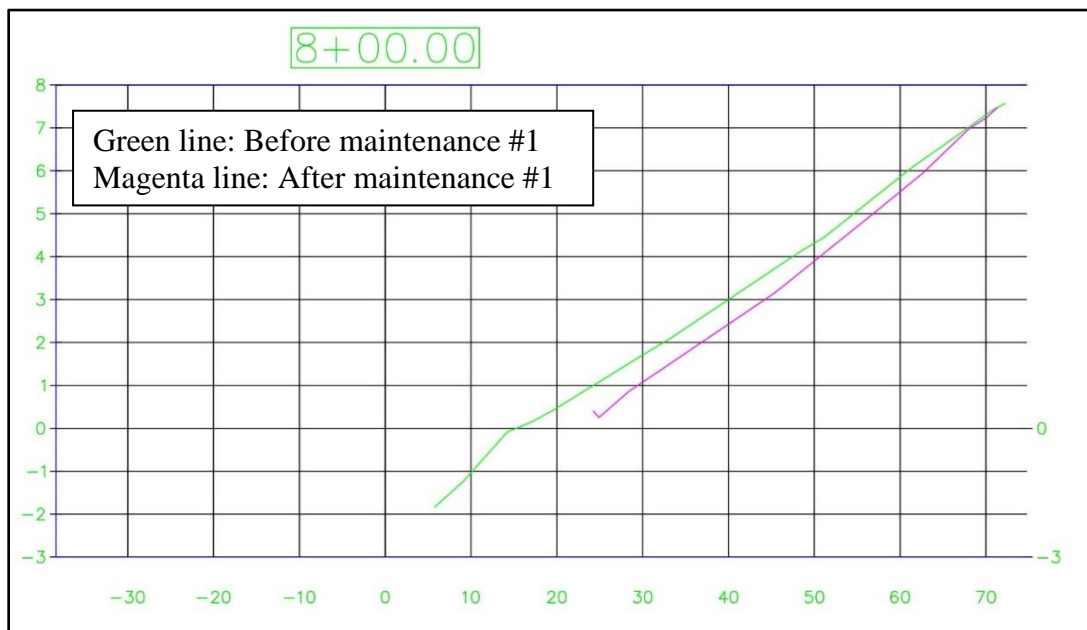
Figure 8-53. Sugar Cove beach profile 8+00 beach maintenance #1

Berm maintenance material was heavily attacked during the consequent winter months by exceptionally large and frequent wave events associated with the 2015 – 2016 El Nino.
