SUBJECT: PETITION TO REMOVE HISTORIC PROPERTY "FALLS OF CLYDE"
FROM HAWAII REGISTER OF HISTORIC PLACES PER HAR §13-198-10(1)

THE FOUR-MASTED IRON SHIP *FALLS OF CLYDE*: EVALUATION OF LOSS OF INTEGRITY AND RECOMMENDATION FOR DELISTING FROM THE NATIONAL REGISTER OF HISTORIC PLACES

James P. Delgado, Ph.D.

May 10, 2023

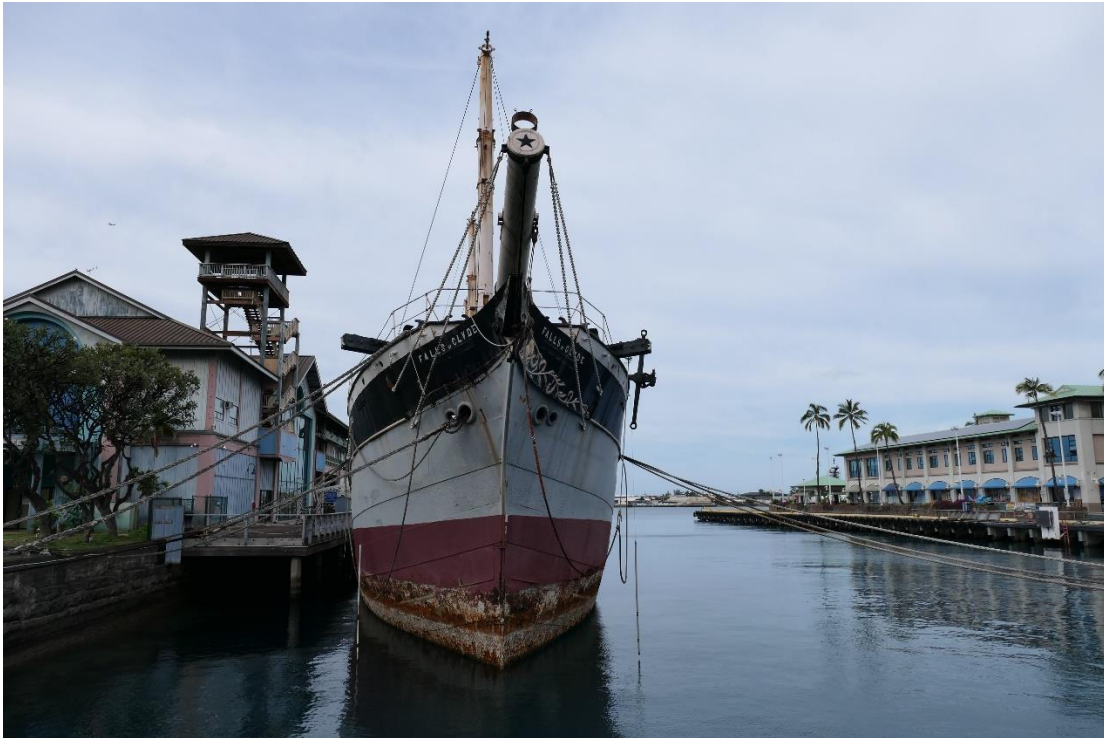
Figure 1: Bow view of *Falls of Clyde*, March 2023 (Joseph Lombardi).

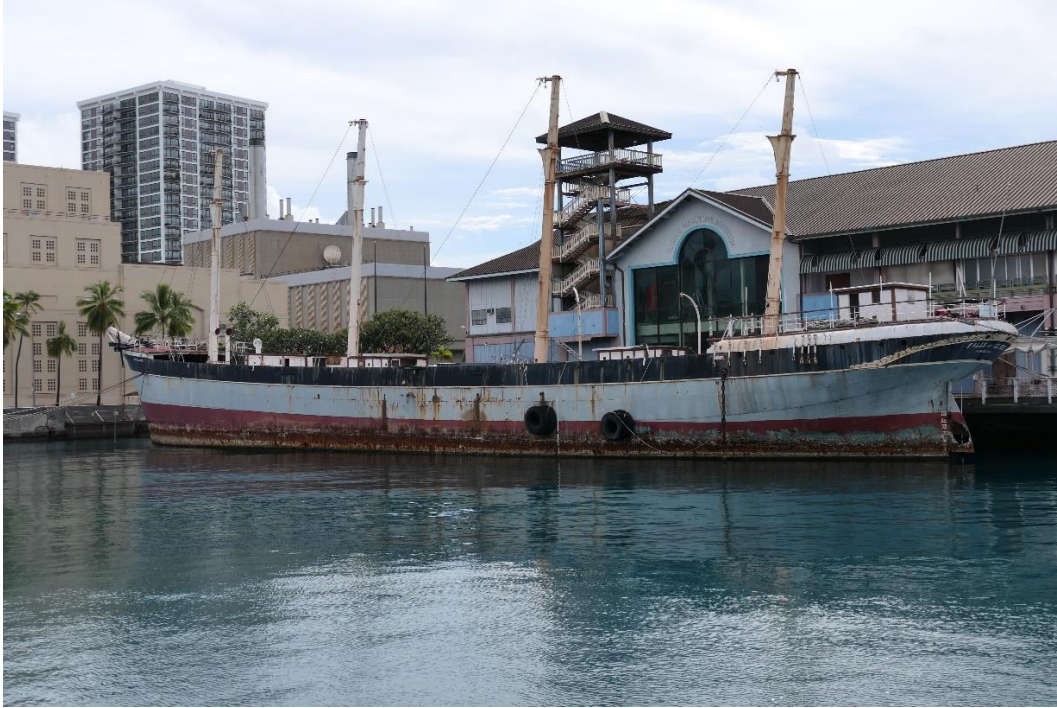
Figure 2: Profile view of the down-rigged *Falls of Clyde* (Joseph Lombardi).

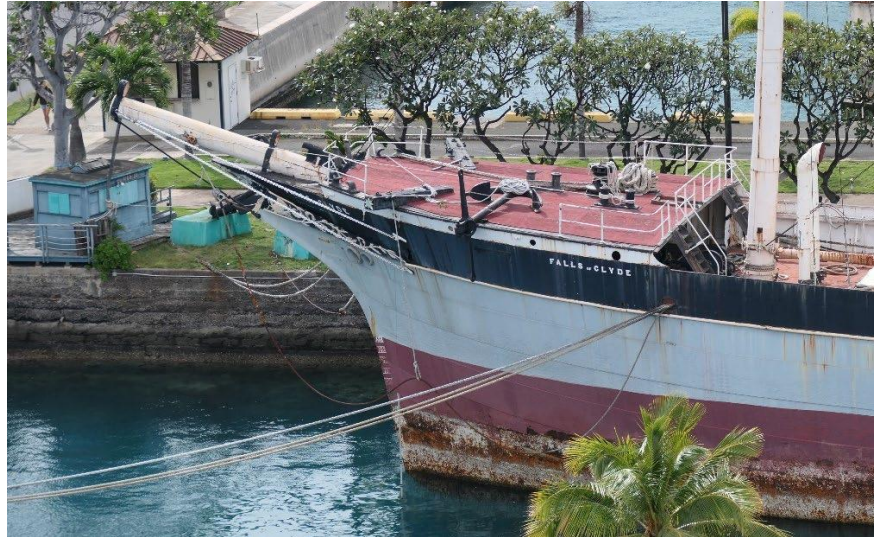
Forecastle deck of FALLS OF CLYDE from the ALOHA TOWER.

The starboard anchor has been removed from the deck.

The figurehead with port and starboard running light pedestals are stored on maindeck.

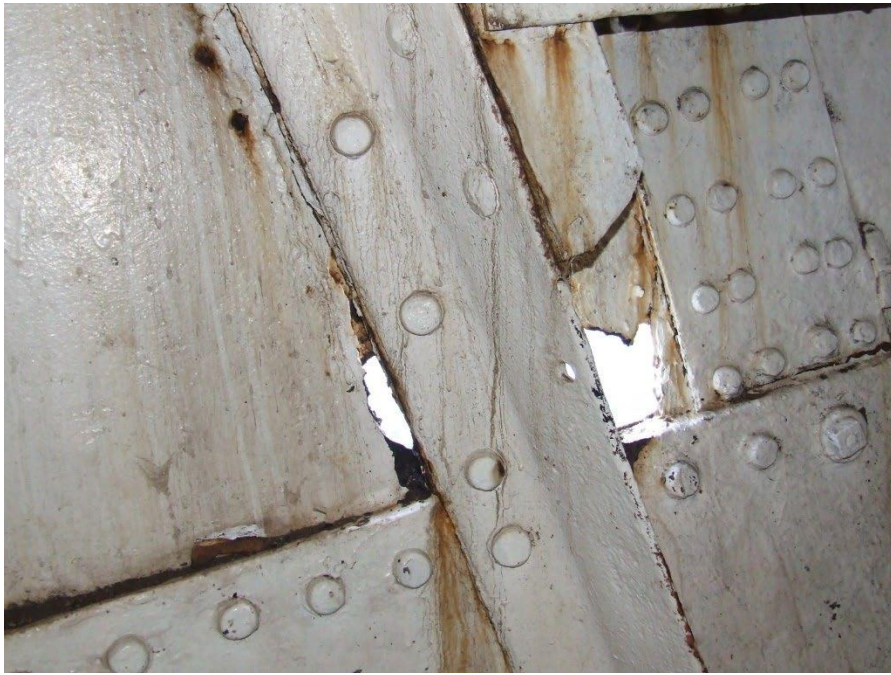
Wasted transverse frame/rivets and separated shell plating to starboard.

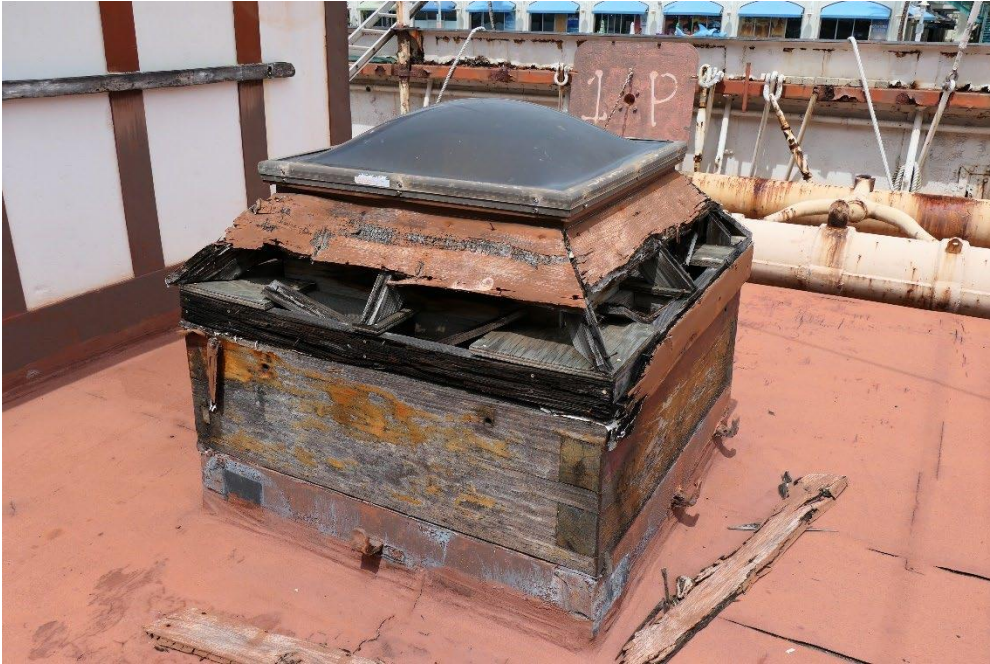
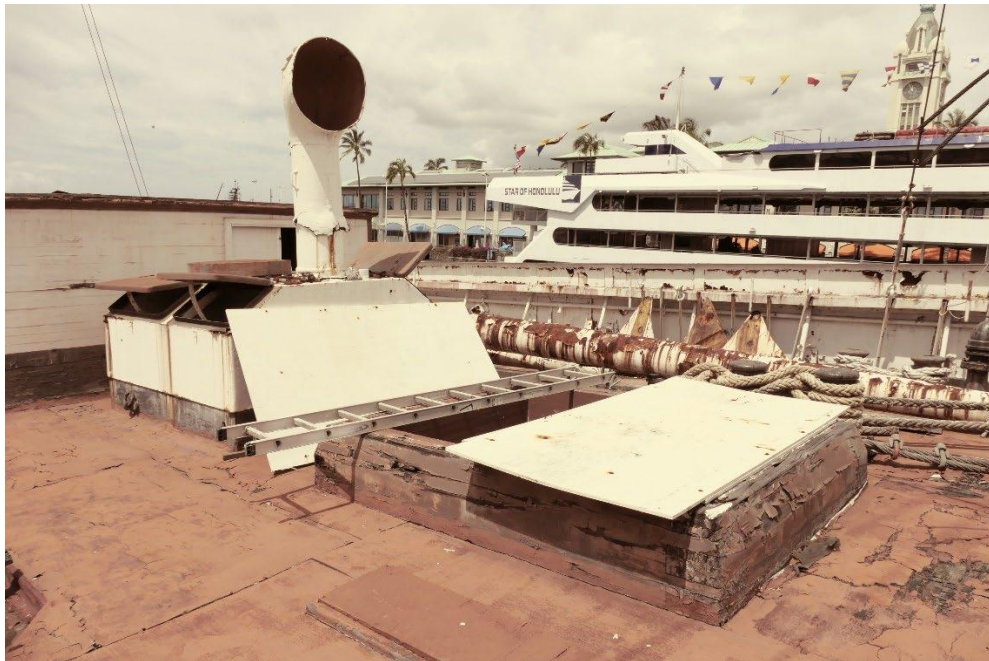
All deck houses have rotted structures, wasted roof materials and all have heavy mildew and rot.

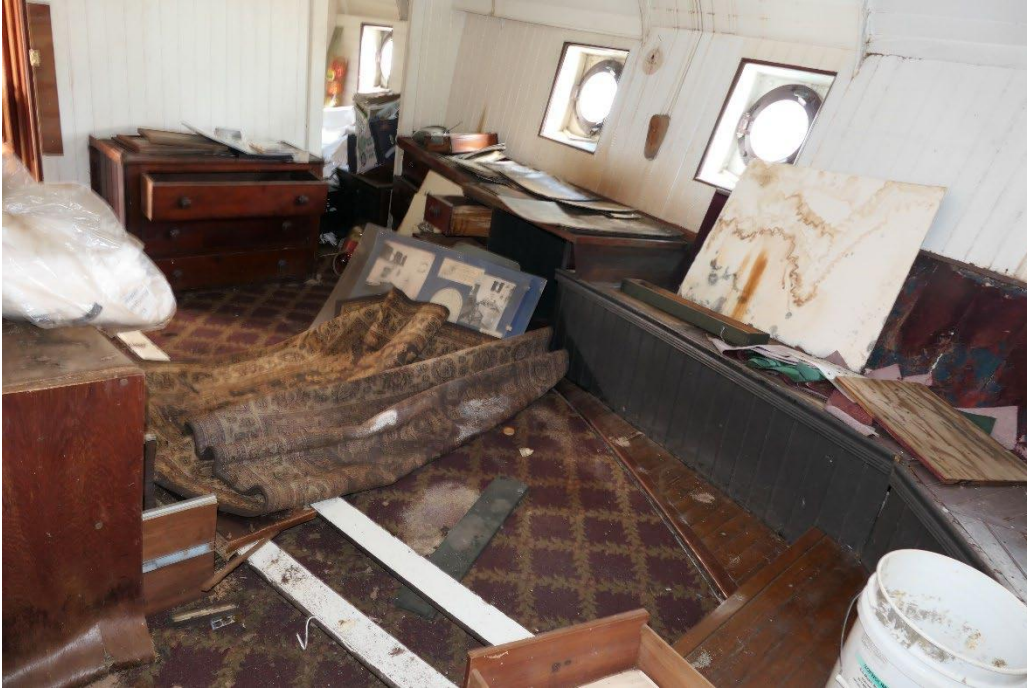
Captain's cabin showing debris strewn about space.

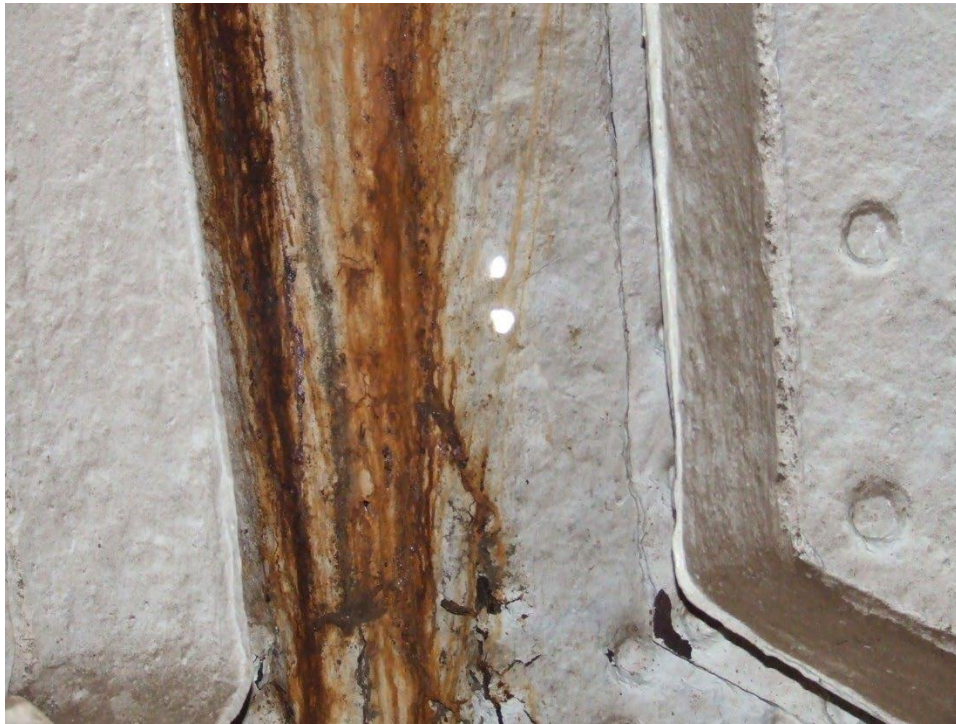
Holed and severely wasted shell plating at stem.

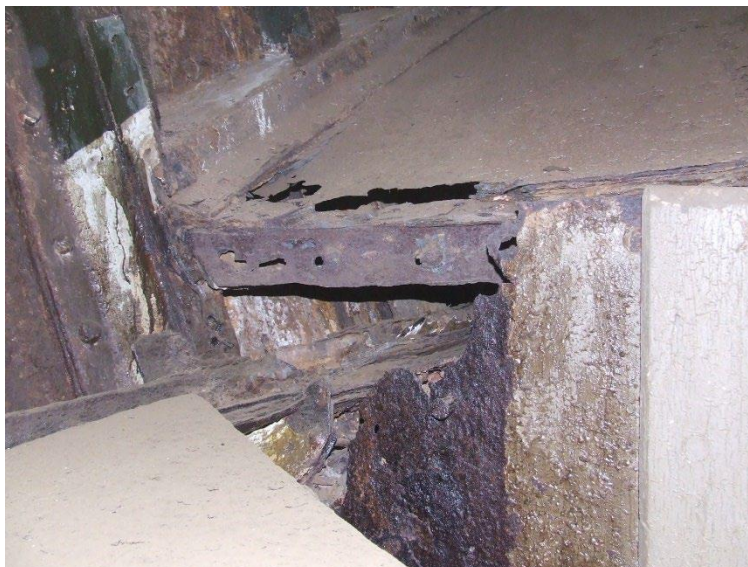
This space is in total disrepair with totally wasted and/or broken transverse frames. Many rivet seams missing rivets; much wastage/scale of remaining rivets. The containment plating for the chain locker has failed.

Shell plating holed in many areas that have been patched from the exterior with wooden plugs below the waterline; open holes remain above the waterline. Shell plating wastage exceeds 70%+.

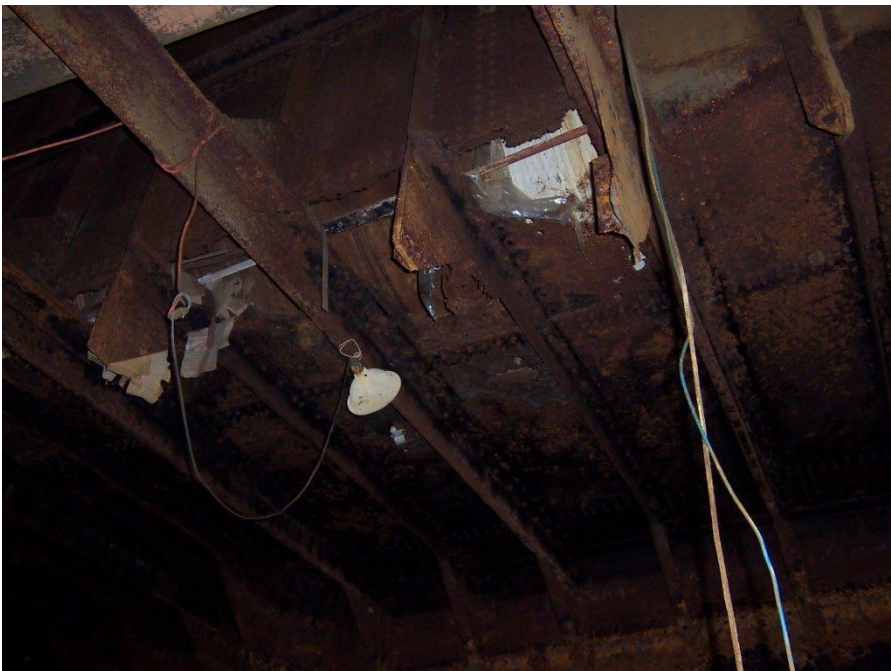
The overhead floor to the Boiler room is badly holed indicating a possible failure.

Wasted deck and scantlings below boiler flat, Tank #1 starboard.

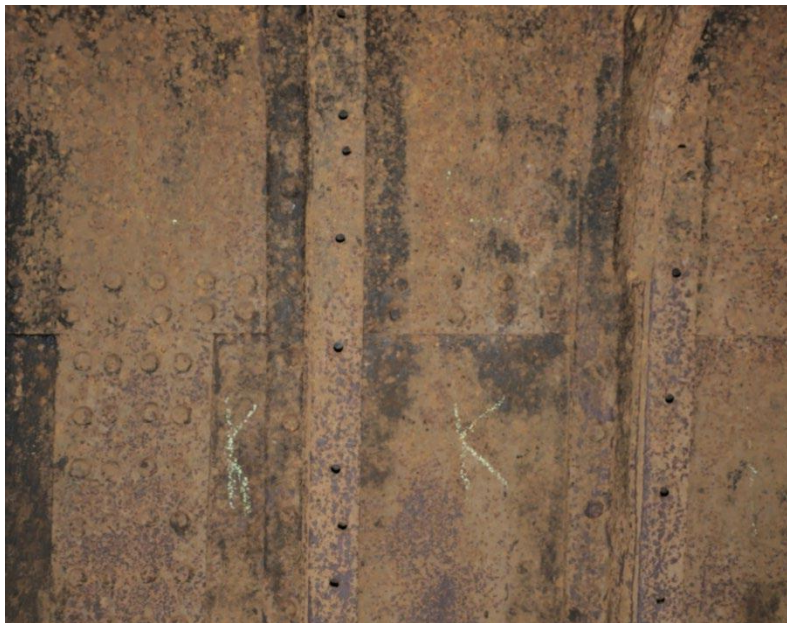
Tank #4 starboard showing wasted side shell plating and non-existent rivets.

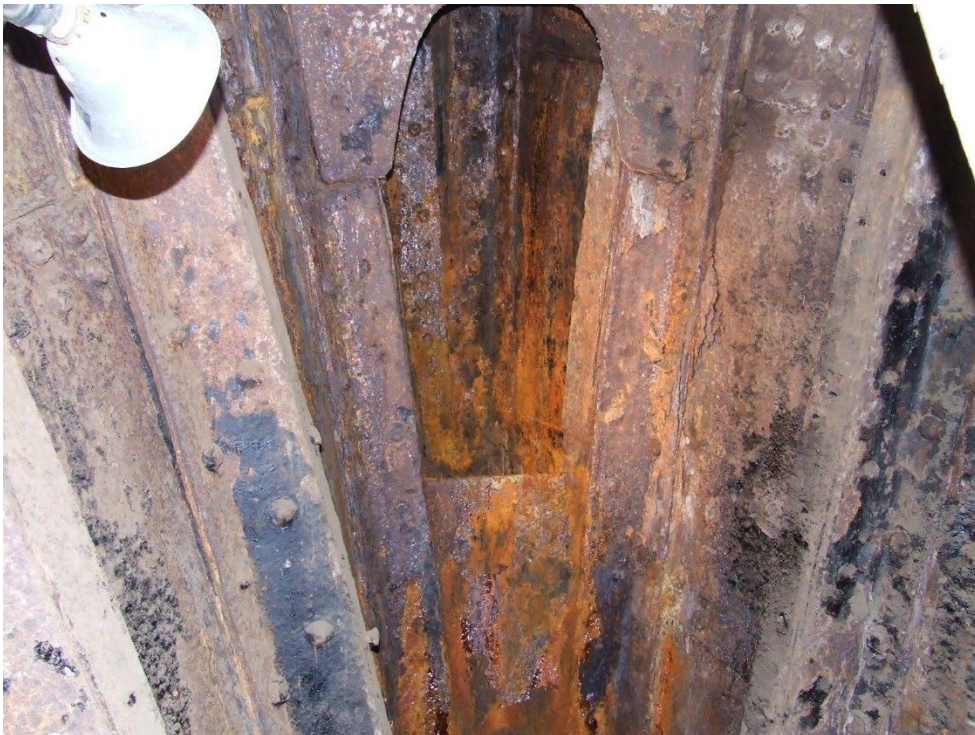
The stern casting is in very poor condition with major degradation and waste apparent.

Stern casting, inboard face showing much wastage.

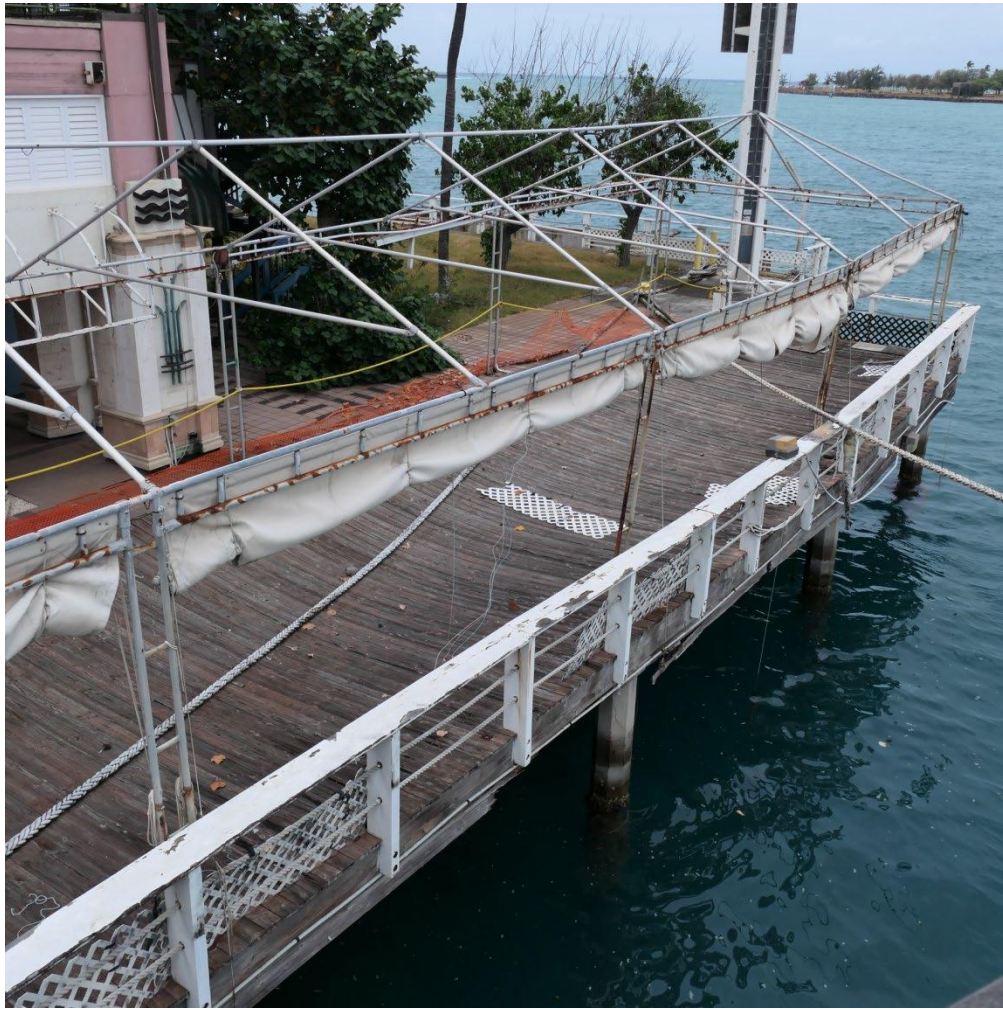
The wooden pier at the stern of FALLS OF CLYDE is collapsing. The mooring bollards secured to the concrete cap rail of the dock have heavily wasted steel pins; these cannot be relied upon going forward to properly secure the vessel. Fendering for the FALLS OF CLYDE is haphazard and much evidence of chafing against the concrete pier is apparent.

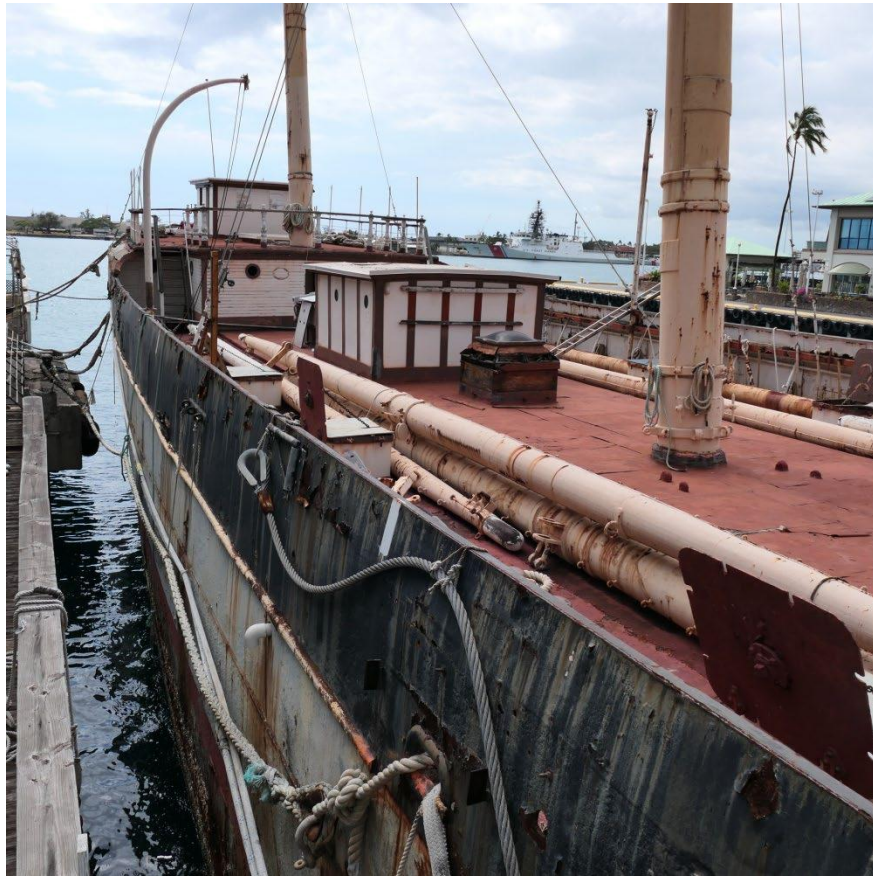
Looking aft at FOC mooring system showing lack of fendering.
